Case study. Site investigation - Hereford.

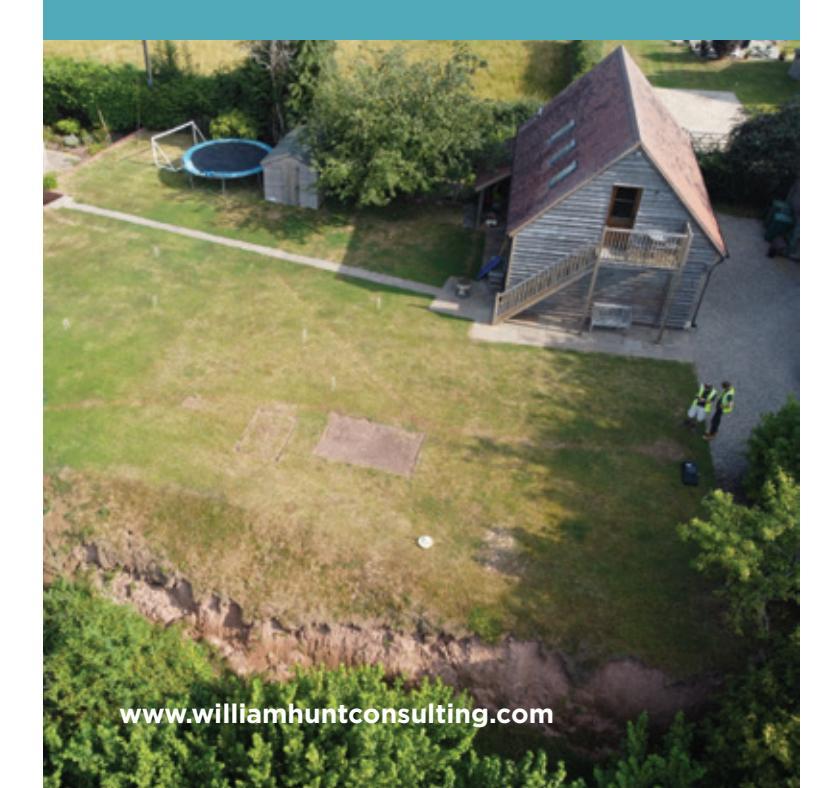
William Hunt Consulting were asked to assist on a job where a substantial landslip had occurred in a garden, close to the insured property.

Understanding of the failure had been limited with fear that the slope failure was progressing and would soon threaten the stability of the property. We were asked to provide an initial assessment of the slope together with monitoring options.
